STRAIGHT RUN DAM

NDI No. Pa. - 283

PHASE I INSPECTION REPORT  
NATIONAL DAM INSPECTION PROGRAM

GAI CONSULTANTS, INC.  
570 BEATTY ROAD  
MONROEVILLE, PENNSYLVANIA 15146  
AUGUST 1978

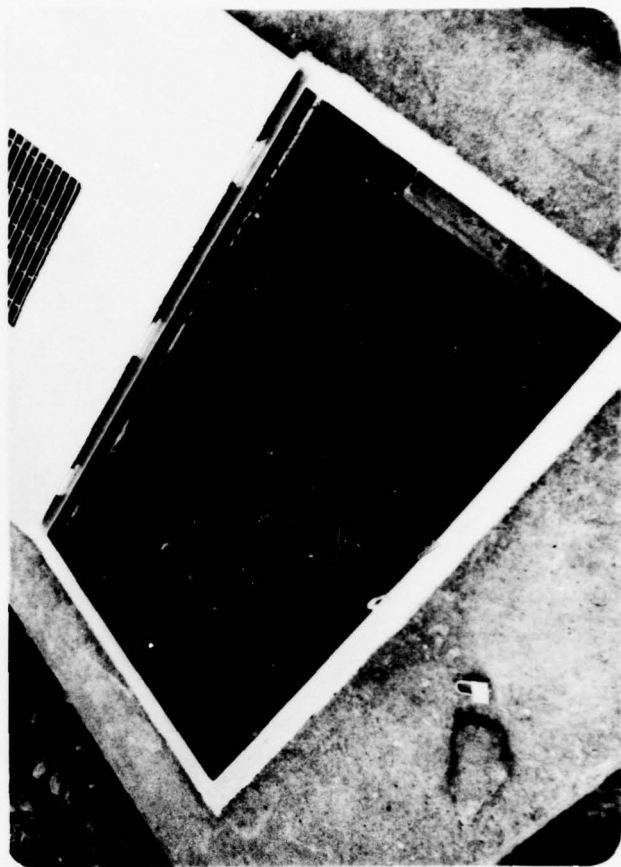
Access - The gate control is located within the riser. It is situated on a ledge just below the roof hatch and is readily accessible (see Photograph 4).

PHOTOGRAPH 4 View of the gate valve on the outlet works of Straight Run Dam.

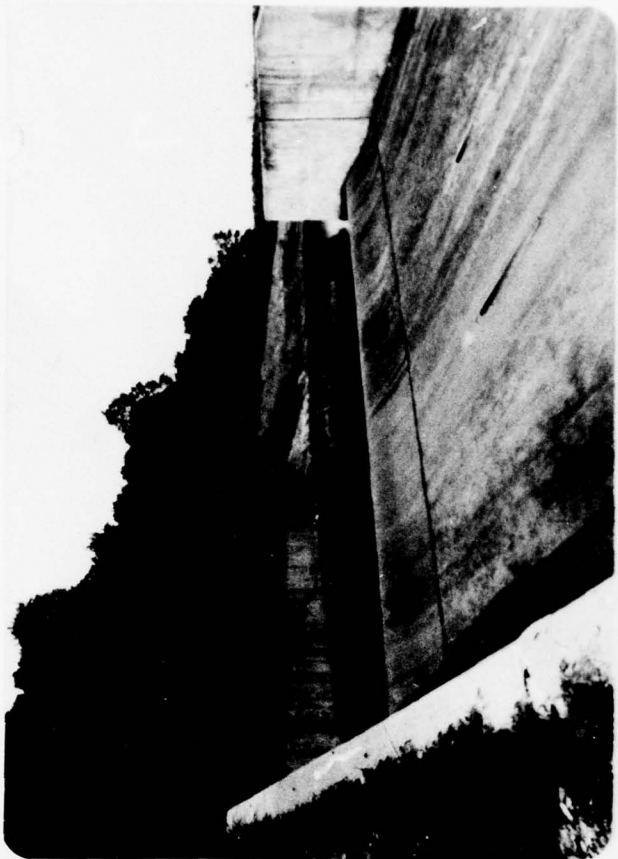
6

1. Emergency Spillway. The emergency spillway is in good condition (see Photographs 6, 7, and 8). Some minor spalling and scaling were located along isolated areas of the spillway wingwalls. Slight vertical movement was noted at several wingwall construction joints but the movement is not considered to be a problem at this time.

d. The owner patch, repair, and seal those areas in the spillway exhibiting minor concrete deterioration.

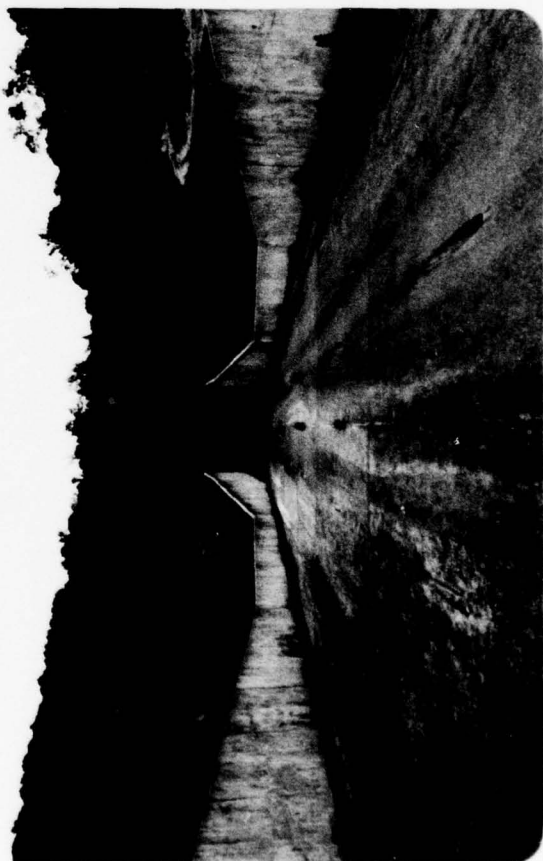
7

Downstream Channel - Concrete spillway chute empties into a stilling basin before discharging into a broad floodplain less than 200 feet downstream of the embankment (see Photograph 7).
